THE VULNERABILITY OF COMMERCIAL AIRCRAFT
AVIONICS TO CARBON FIBERS

Jerome A. Meyers and Seymour Salmirs

THE BIONETICS CORPORATION
Hampton, Virginia 23666

NASA Contract NAS1-15238
April 1980

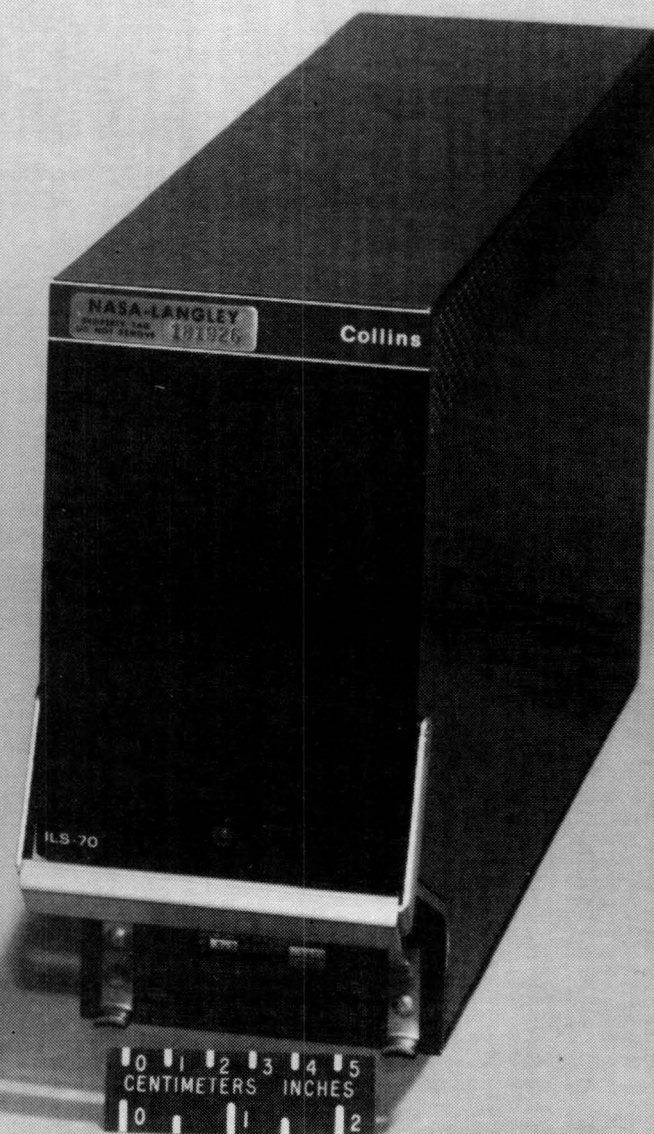
FIGURE 9: THE ILS RECEIVER

The ILS Receiver, (Figure 9), is shown with the dust cover off in Figure 9A. Physical size is approximately 9 x 20 x 38 cm and weight is 4.1 kg. The dust cover is perforated with 3.2 mm (1/8 inch) holes located in two strips at the top of both sides; the rectangular strips are 4 x 36 cm's. The cover also has a rectangular set of holes in its bottom that is 5 x 8 cm's. No specific cooling requirements were set forth in the repair manual and the operating temperature limits were high. Since 30 meters/minute (100 FPM) is an estimate of the airflow to be seen in an aircraft electronic bay this flow was used in testing.
